## Alliance 768 Value Plus: “Gets pivot irrigation systems going”

6 May 2021 by Yokohama Off-Highway Tires

**New pattern for pivot irrigation systems / Designed for hot regions, wet crops and muddy soils / Rounded shoulders for optimum traction and effective protection of the crop / Strong nylon carcass and ozone component for prolonged service life / Three sizes available /**

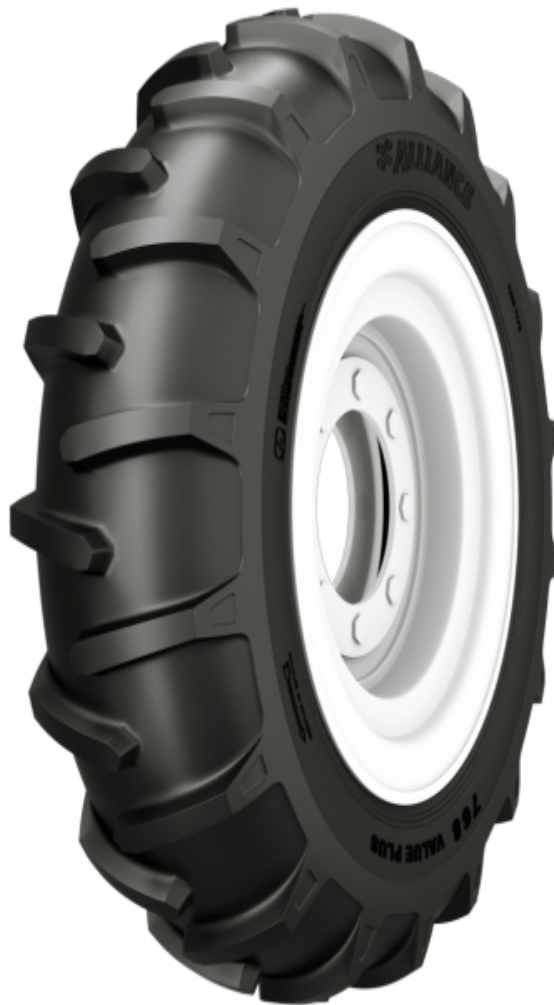
ALLIANCE 768 VALUE PLUS

As part of the manufactures portfolio of value segment tires, Alliance (a part of **Yokohama Off-Highway Tires**) introduces a new tire for pivot irrigation systems: Alliance 768 Value Plus. It is a completely new tire pattern which has been designed to provide effective grip and traction for constant loads being moved on fixed circular paths under moist or even muddy conditions. Wide spacing of lugs ensures that the excellent self-cleaning characteristics are maintained at all times whilst rounded shoulders provide constant propulsion and protect the crop against damage at the same time. The strong nylon carcass allows for a prolonged and reliable service live.

Well known in hot and arid regions, pivot irrigation systems have to function reliably under most adverse conditions, i.e. high temperatures and highly intensive sun radiation. At the same time, soil and irrigated crops tend to make for a moist or even muddy working environment. That is why the Alliance 768 Value Plus features a special ozone compound which eliminates premature aging and cracking of the tread. As climate change continues, irrigation systems including pivot irrigation will also increasingly be needed in semi-arid regions, for example. With the brand-new Alliance 768 Value Plus and the three sizes 11.2-24, 14.9-24 and 11.2-38, Alliance offers the perfect tire solution.
